World's largest offshore drilling contractor standardises on FLIR

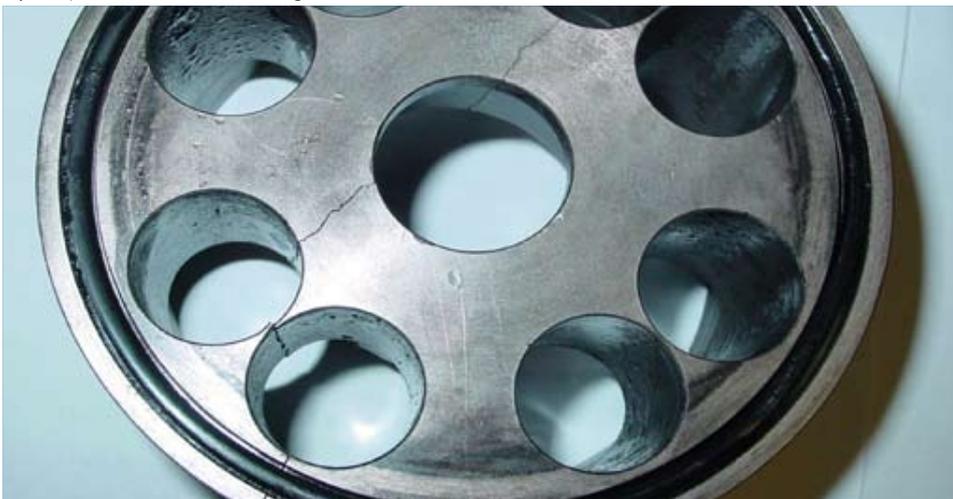
Glycol Pp Suction Vv Guide Damage

"With my FLIR camera I was able to prevent this unnecessary procedure," Bob continued. "By looking at the thermal pattern on the second, healthy glycol pump and using that as a benchmark, I was soon able to pinpoint the problem to the suction valve. A quick examination of the suction valve soon revealed one of the guides was cracked." The faulty component was swiftly replaced saving in the region of 12 hours labour.
