COMPACT THERMAL IMAGING CAMERA FROM FLIR CONTINUOUSLY MONITORS PACKAGING QUALITY

PACKAGING AND PRODUCT QUALITY

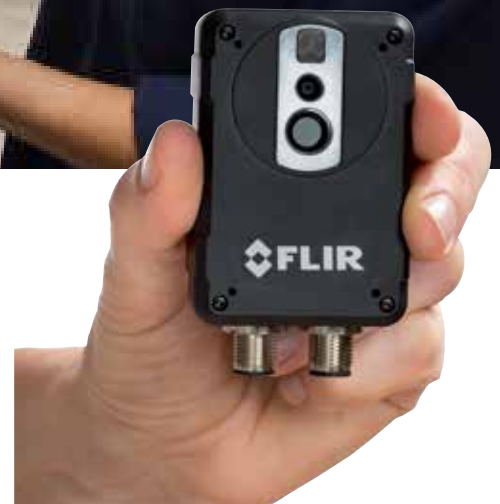
Combining thermal and visual cameras in a small, affordable package, the AX8 provides continuous temperature monitoring and alarming capabilities.

FLIR AX8 is a thermal sensor with imaging capabilities. Combining thermal and visual cameras in a small, affordable package, the AX8 provides continuous temperature monitoring and alarming for of critical electrical and mechanical equipment.

The AX8 helps you guard against unplanned outages, service interruptions, and equipment failure. You'll get the benefits of continuous condition monitoring and hot spot detection without the need for periodic manual scans. The AX8 measures only 54 x 25 x 95 mm, making it easy to install in space-constrained areas for uninterrupted condition monitoring of critical electrical and mechanical equipment.

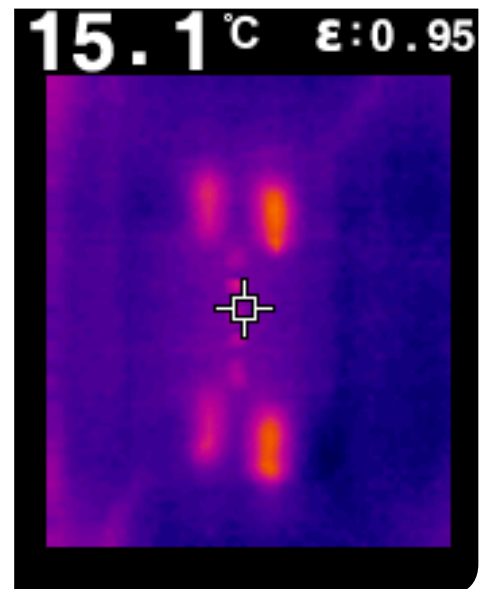
The FLIR TG165 proved to Recochem that thermal imaging cameras can see through cardboard and check the pattern and size of the applied glue spots. This meant that it was no longer necessary to destroy the boxes for inspection.

Adam Wolszczan used the TG165 to have a look at some of the boxes that come off the production line and the camera clearly showed him where the hot glue spots were located. What's more, the FLIR TG165 thermal imaging camera was able to "see" through the cardboard and check the pattern and size of the applied hot melt adhesive. This meant that it was no longer necessary to destroy the boxes for inspection. It convinced Adam Wolszczan that thermal imaging technology was the path to be followed: "We contacted FLIR Systems and found a suitable solution with the FLIR AX8 thermal imaging sensor. The AX8 is very affordable and very compact: just what we needed for our application."

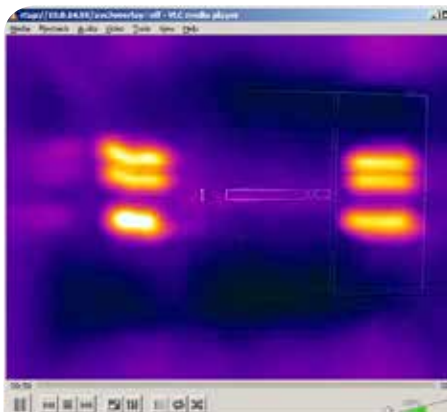
If you look at the AX8 thermal images, then you clearly see the hotter spots where the glue has been applied. Whenever a glue gun is delayed, you see a position shift of the hot spots, so you instantly know when something is wrong.

"If you look at the AX8 thermal images, then you clearly see the hotter spots where the glue has been applied. Whenever a glue gun is delayed, you see a position shift of the hot spots, so you instantly know when something is wrong. It's very straightforward and very effective."

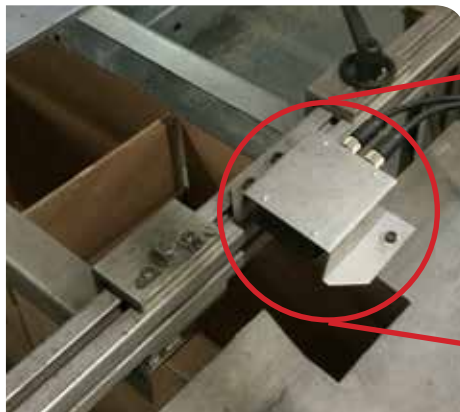
The AX8 camera is set up to look at predefined areas of the flaps where glue should be applied, and verify spot sizes and their temperatures.

The AX8 camera is now set up to look at predefined areas of the flaps where glue should be applied, and verify spot sizes and their temperatures. Thanks to its compact size, the AX8 thermal imaging sensor can be installed in such a way that it can look at the bottom of the box. And since the AX8 can see the heat through the carton, it is no longer needed to destroy any more boxes for inspection. The acquired video images
