FLIR thermal imaging cameras help ensure the impeccable quality of SOLON solar modules

'Thermal imaging is a great tool both for quality control during production and for field inspections'

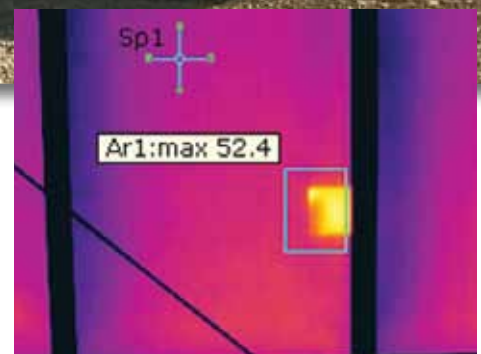
This thermal image shows a hot spot due to cell breakage in a standard 60 cell module.

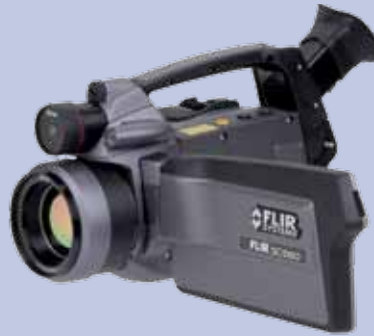
FLIR SC660: a perfect tool for shunt detection tests

- 640 x 480 pixels resolution
- <30 mK sensitivity, accuracy +/- 1% of reading
- Wide range of lenses
- Extended measurement functions
- Sequence recording in camera
- Contrast Optimizer

The model currently on the market for this type of application is the FLIR SC660 thermal imaging camera. Its uncooled microbolometer detector provides thermal images at a resolution of 640 x 480 pixels at a thermal sensitivity below 30 mK. It contains automatic contrast optimizing algorithms that make it easier to make thermal analyzes of detailed objects. Combined with exchangeable lenses and the most advanced camera features this makes the FLIR SC660 a perfect tool for solar cell shunt detection tests.

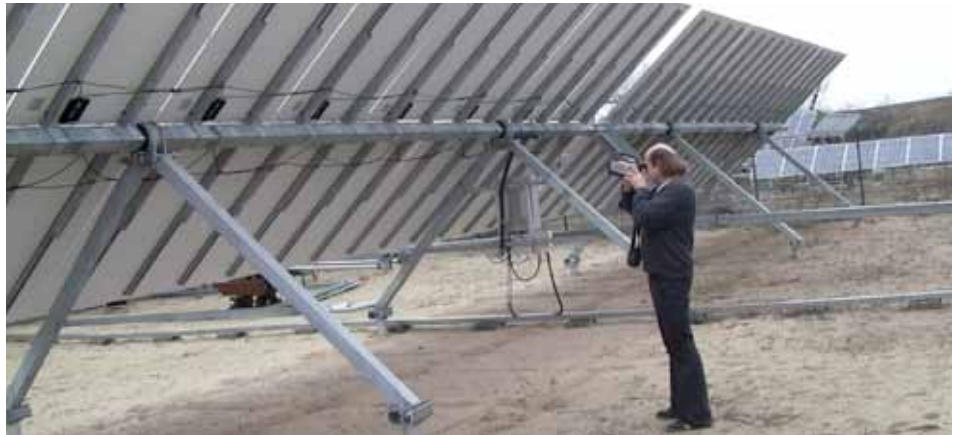
Volker Denzler, thermography expert at SOLON's after sales services department, takes thermal images from the back of a module to avoid reflections.

“Especially the tiltable lens unit is very practical”, explains Denzler. “When we’re inspecting a module in the field we usually try to look at the back, if the installation allows it. With the tiltable lens unit we can effortlessly capture the back of a solar module without having to crawl on the ground. Due to this ergonomic design feature we can effortlessly point the

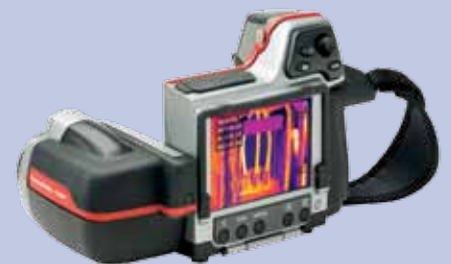
T-Series: perfect for field inspections

Developed for maintenance inspections these cameras have been designed for maximum usability. Especially the tiltable lens unit makes them very practical.

The FLIR T-Series thermal imaging cameras currently used for field inspections all contain an uncooled microbolometer detector with 320x240 pixels resolution that produce crisp thermal images at a thermal sensitivity of below 50 mK. Especially developed for maintenance inspections these cameras have been designed for maximum usability. They are compact, lightweight and ergonomically designed.

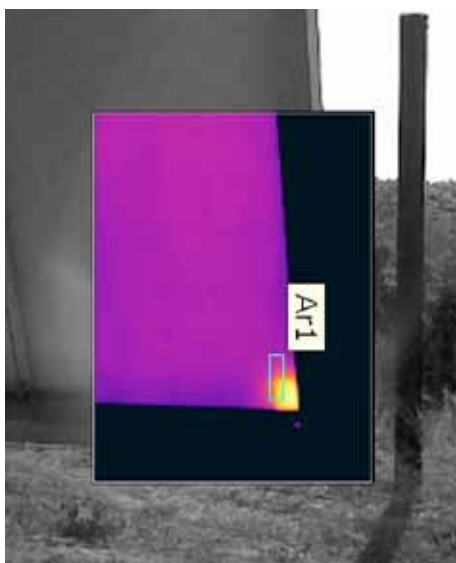
This Picture in Picture image shows a hot cell due to a shadow from the nearby alarm system.
